DEPARTMENT OF TRANSPORTATION**DIVISION OF ENGINEERING SERVICES**

Quality Assurance and Source Inspection

Contract #: 04-0120F4Cty: SF/ALA Rte: 80 PM: 13.2/13.9File #: 69.28**WELDING INSPECTION REPORT****Resident Engineer:**Siegenthaler, Peter**Address:** 333 Burma Road**City:** Oakland, CA 94607**Report No:** WIR-024031**Date Inspected:** 21-Apr-2011**Project Name:** SAS Superstructure**OSM Arrival Time:** 700**Prime Contractor:** American Bridge/Fluor Enterprises, a JV**OSM Departure Time:** 1900**Contractor:** Zhenhua Port Machinery Company, Ltd (ZPMC), Changxing Island **Location:** Shanghai, China**CWI Name:** Xu Le Feng**CWI Present:** Yes No**Inspected CWI report:** Yes No N/A**Rod Oven in Use:** Yes No N/A**Electrode to specification:** Yes No N/A**Weld Procedures Followed:** Yes No N/A**Qualified Welders:** Yes No N/A**Verified Joint Fit-up:** Yes No N/A**Approved Drawings:** Yes No N/A**Approved WPS:** Yes No N/A**Delayed / Cancelled:** Yes No N/A**Bridge No:** 34-0006**Component:** TOWER Components**Summary of Items Observed:**

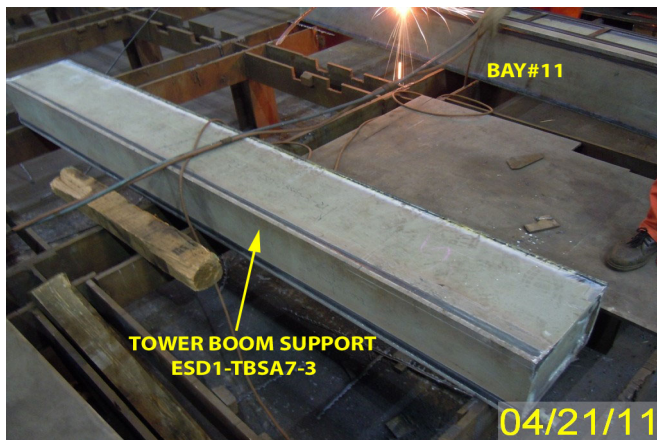
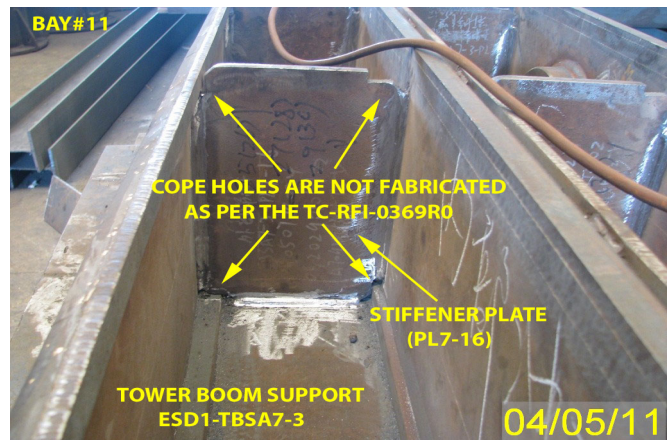
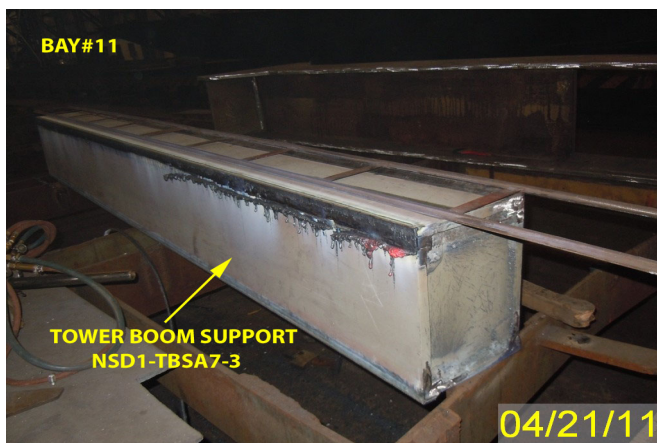
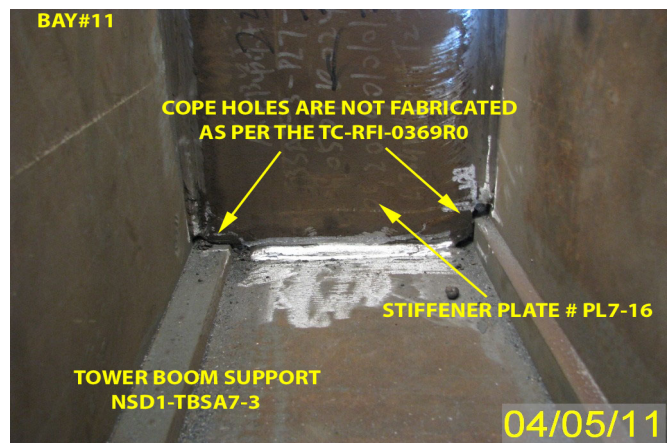
During the Caltrans Quality Assurance (QA) in-process observation on lift-6 tower boom supports, this QA Inspector discovered the following issue:

- ZPMC personnel sealed the Tower Boom Supports without allowing for QA visual confirmation that these corrections had been completed.
- On date: 4/5/2011 it was observed that the cope hole sizes at all 4 corners on every stiffener plate of Tower Boom Supports (listed below) did not conform to shop drawing#PL7-16. (cope holes 25mm x 25mm)
- Cope hole dimensions were then changed to 15mm x 45mm per TC-RFI-369R0 to address this discrepancy.
- The tower boom supports are identified as:-

1. ESD1-TBSA7-3

2. NSD1-TBSA7-3
